Treatment diagram

Engine compartment:

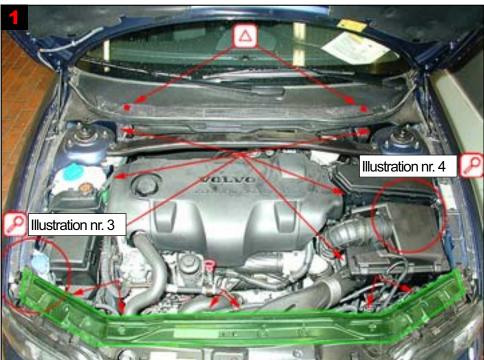
Cowl: Treatment via 2 drill holes in plastic grille. Treatment behind spring struts, on top of longitudinal members, under fluid reservoir, electronic box, fuse box and air filter box. Treatment of locking plate and top member in wing. See fig. 3

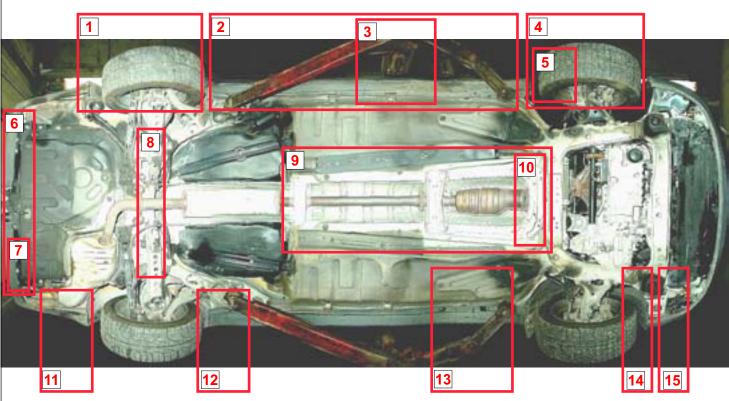
Treatment diagram

Underside

Wheel arch rear: Drill 2 holes for correct treatment. Open lug, remove felt, treat around tail light.

Wheel arch front: Treatment via 2 drill holes and behind wheel arch liner where possible.

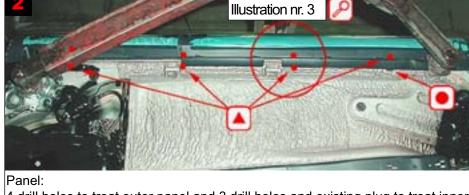
Panel sectional view:

Fig: drilling at correct level.

4 drill holes to treat outer panel and 3 drill holes and existing plug to treat inner panel. See fig 3 for drilling at correct level.
